## Test Report

Product name : PVC film

Test specification : 7 Phthalates

Report No.:NB2025010352

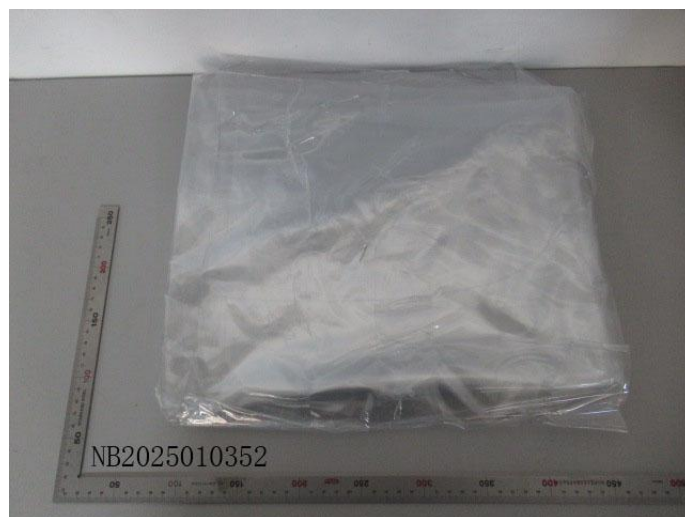
PVC film

Sample photo(s), see annex1
